# Using the 9131-944 Belt Tensioning Tool

**Introduction:** this short document contains a step-by-step guide for using the 9131-944 belt tensioning tool manufactured by ArnnWorx Specialty Tools. This tool is designed to assist with the tensioning of both the cam belt and balance belt on the Porsche 944.

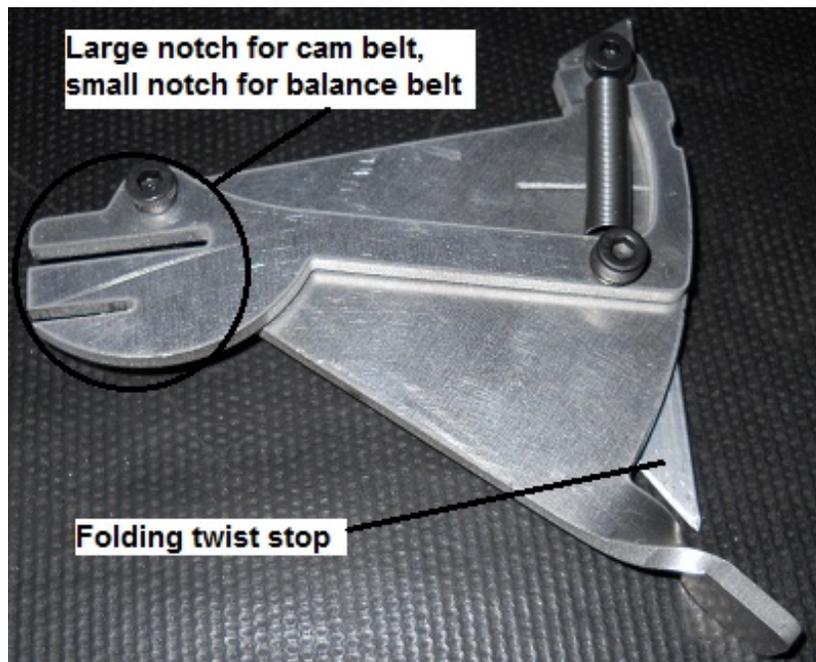
1. Ensure the twist stop arm is extended as seen in the image at the top of this document. The angle of the arm is not critical; a final positioning of it will be done just prior to the reading.
2. Insert the tool onto the 5<sup>th</sup> open belt notch (count left from the upper balance belt cog). Be sure to use the small notch of the tool.

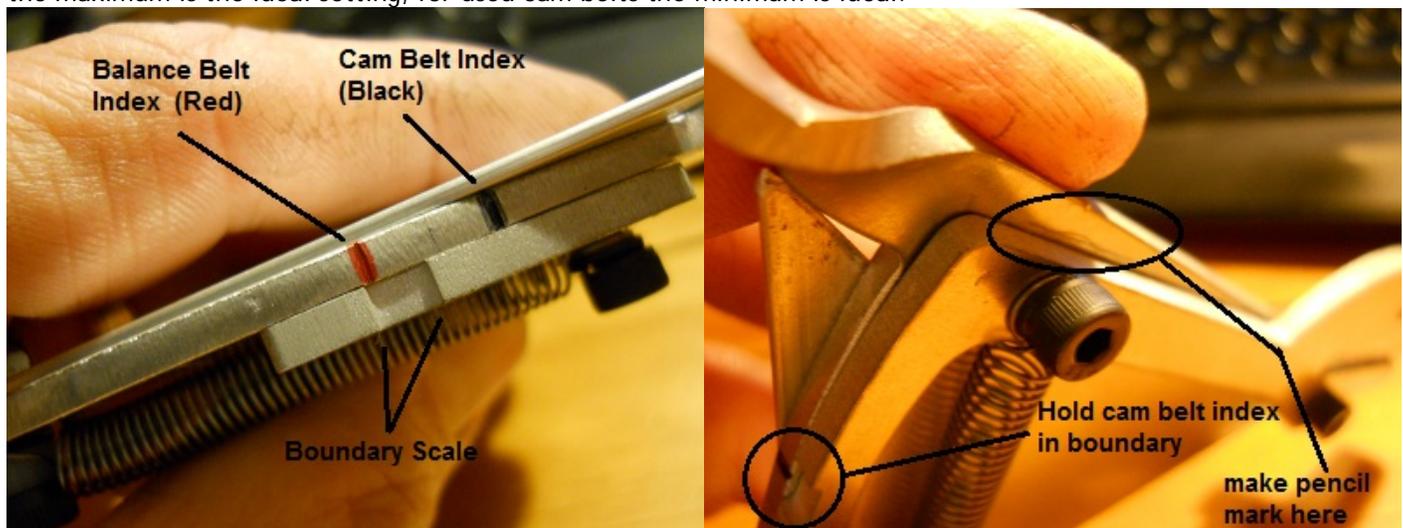
The 9131-944 uses colored index marks together with a moving boundary scale. Reading the scale is simple, when the index is within the boundary, the belt is tensioned correctly. Refer to the image below - the left edge of the boundary scale notch represents the maximum acceptable boundary and the right is the minimum. For new cam belts, the maximum is the ideal setting, for used cam belts the minimum is ideal.

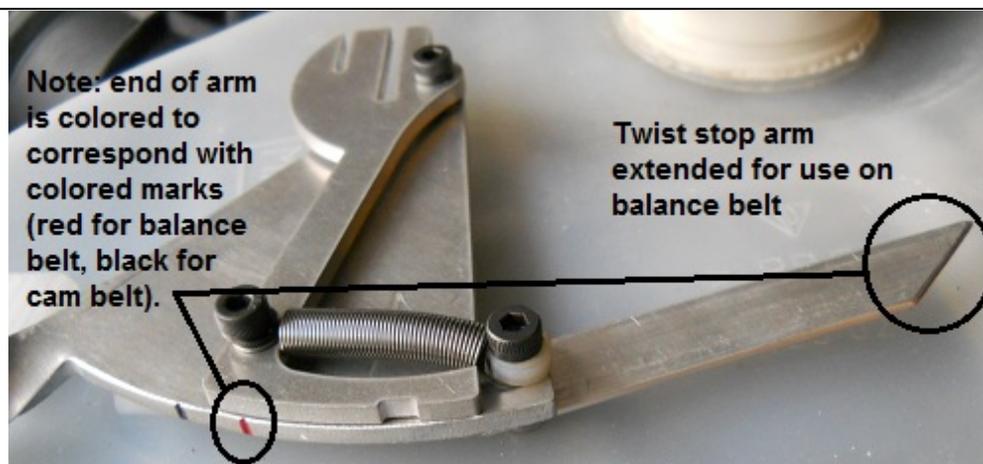
There is only a very small area along the lower span of the cam belt where the 9131-944 tool can work. When in that position, the scale is difficult to see. So, we transfer the boundary scale marks to a viewable place on the tool. These are very lightly scribed; you may wish to darken these marks with a pencil.

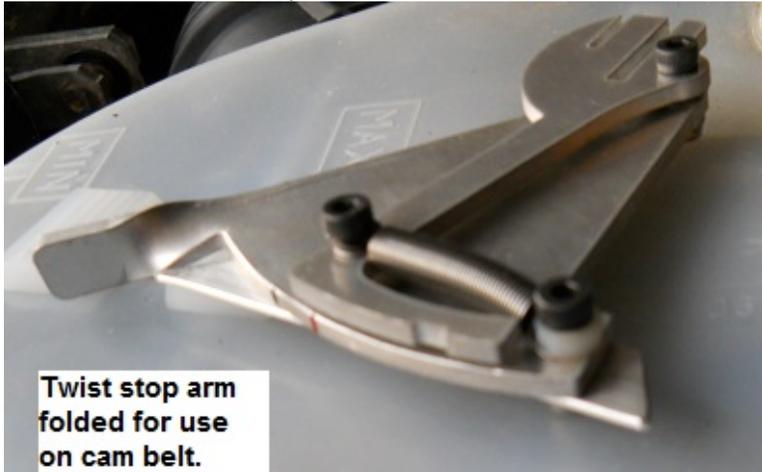
2. Ensure the twist stop arm is folded as shown below.

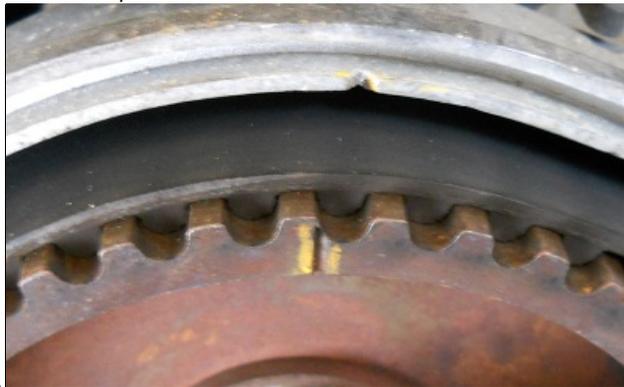
3. Place the car in neutral and set the hand brake. Remove the distributor cap and the cam gear cover. *Note: This procedure assumes the cam belt is pre-set to a tension tight enough so that rotating the crank will not cause the belt to jump or skip over teeth. On engines with the spring tensioner, the spring tensioner must be tightened; else the belt will skip teeth during rotation of the crank.*
4. Using a 24mm socket, rotate the crankshaft and cam until the cam is 1 tooth left of Top

Dead Center.

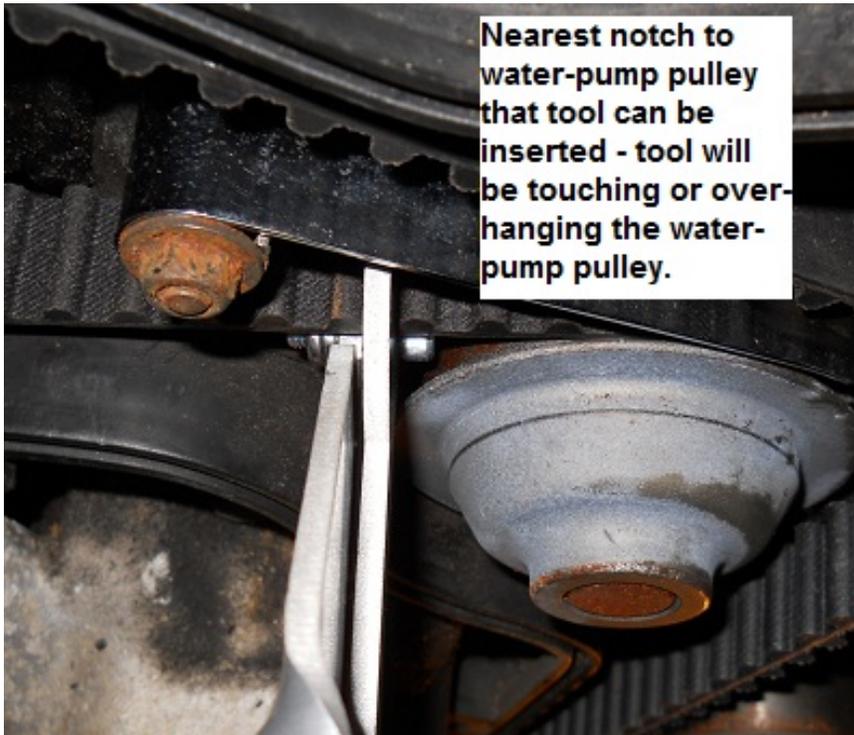
5. Place the tool on the cam belt notch, as near to the water-pump pulley as is possible. At this point, the 9131-944 tool may be touching the water-pump pulley.

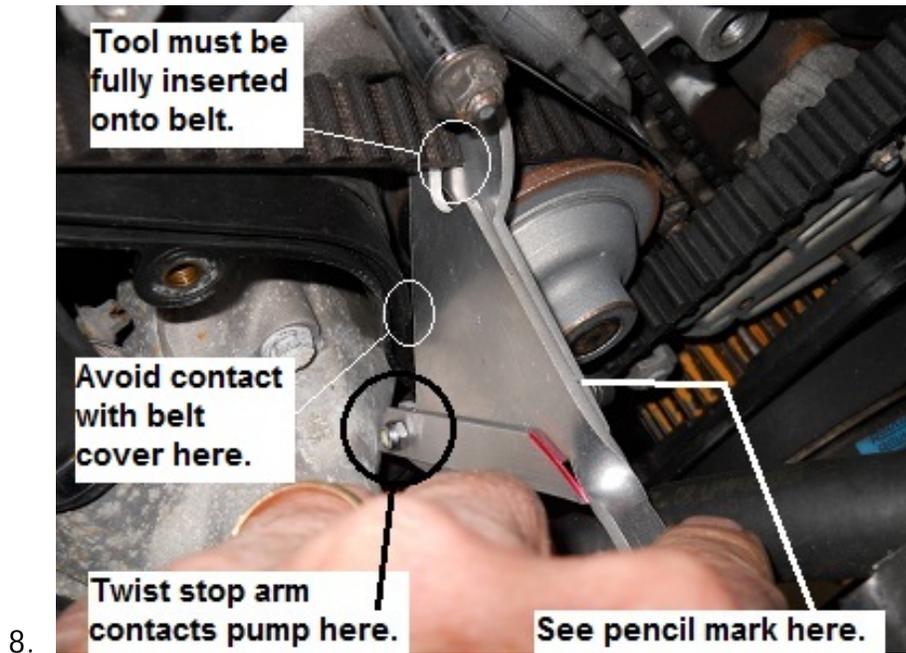
6. While observing the 9131-944, slowly rotate the crankshaft clockwise (approximately  $\frac{1}{2}$  tooth). This will cause the 9131-944 to move away from the water-pump pulley. Stop as soon as the tool is clear of the pulley. In this location the tool can be rotated downward without touching either the belt cover or the water-pump pulley. Also, the clockwise rotation of the crank shifts the belt's slack to the lower belt span (where the tool is located).
7. Gently press down on the tool until the twist stop arm contacts the water-pump. With the arm lightly touching the pump, read the scale (or pencil mark). No belt adjustment is needed if the black mark is within the boundary scale. If an adjustment is needed, then it is best to make the adjustment and then repeat steps 4 through 7.

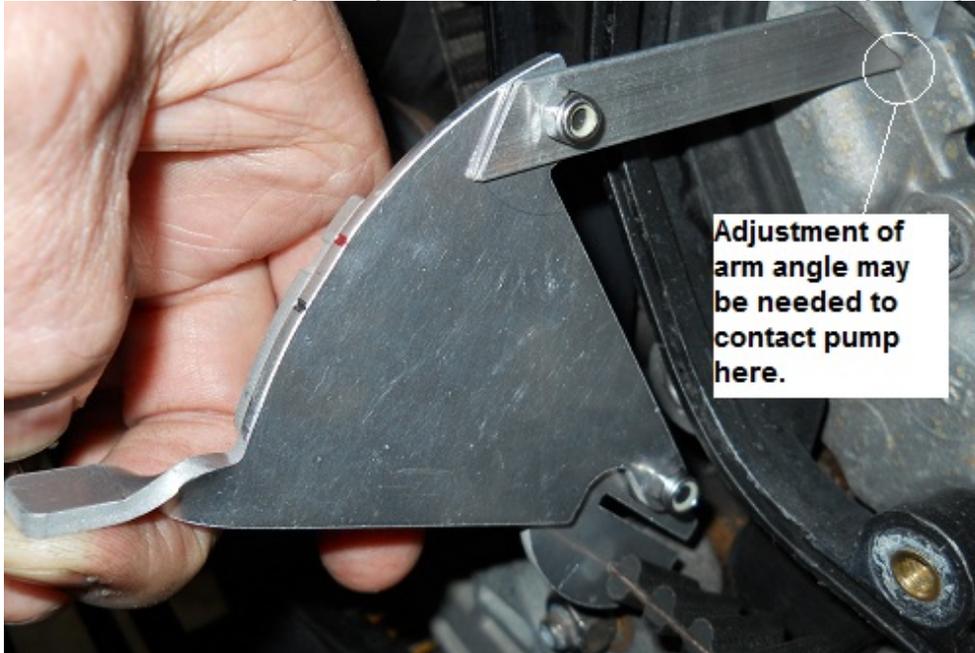
3. Gently press upward on the 9131-944 tool until the twist stop arm contacts the flange of the water-pump (slight adjustment of the twist stop arm angle may be needed).

4. Hold the tool in this position (lightly touching the water-pump) and read the scale. No belt adjustment is needed if the red mark is within the boundary scale. If an adjustment is needed, then it is best to rotate the engine 360 degrees following the adjustment to distribute the belt's tension evenly.
